INVENTORY OF MONUMENTS AT PAGAN

Volume One
Monuments 1-255

PIERRE PICHARD

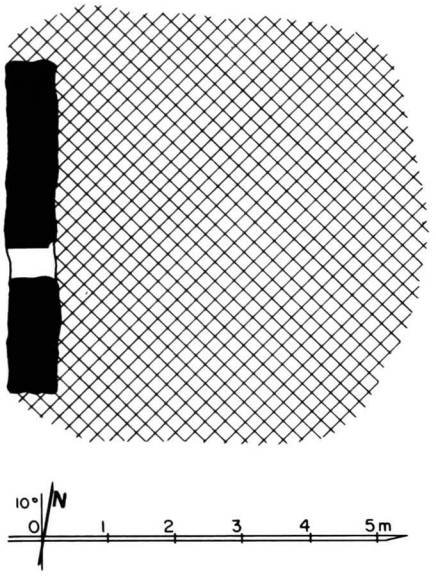
2074 a - Plan

1 general description
- small single-storey monastery.
- in a ruined walled enclosure, together with monastery **2075** and mounds **2073** and **2414**.

5 present condition
- ruined.
- only part of west wall remains.
- present height 2.60 m.
- ground floor buried under debris.

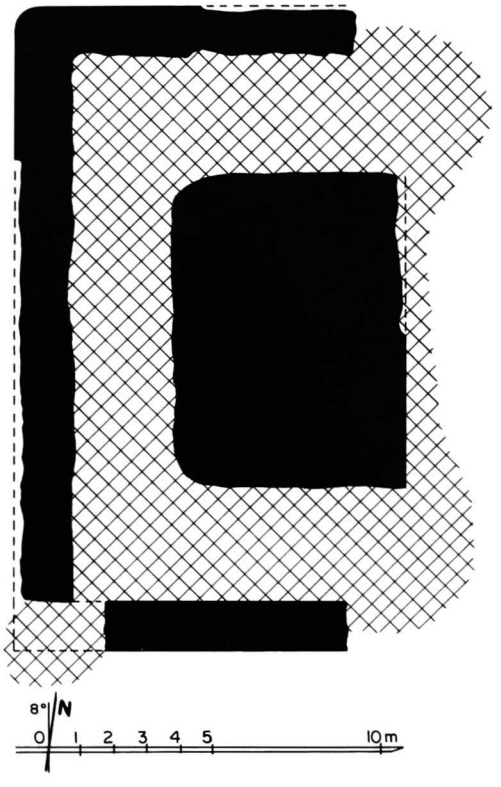
2075 a - Plan

2075 b - From south-east

5 present condition
- ruined.
- vault and roof collapsed.
- only west part remains.
- ground floor buried under debris.

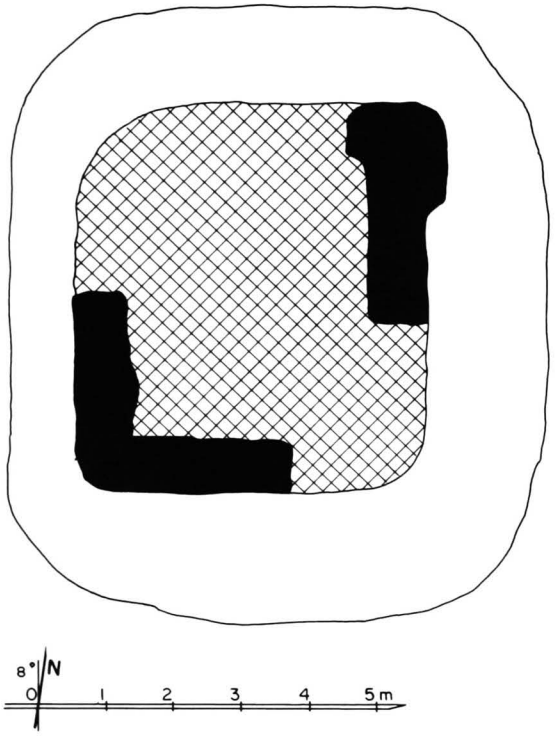
2076 a - Plan

1 general description
- small single-storey monastery.

5 present condition
- ruined.
- walls and vault collapsed.
- ground floor buried under debris.
- structure badly cracked.

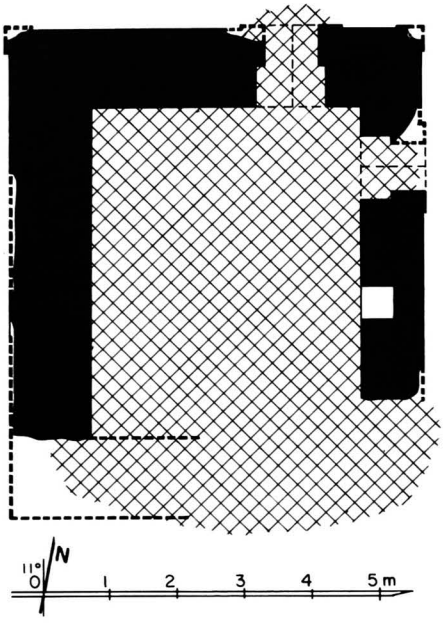
2077 a - Plan

1 general description
- small single-storey monastery.
- formerly with a timber pavilion on east side (?).

5 present condition
- ruined.
- south wall, vaults and roof collapsed.

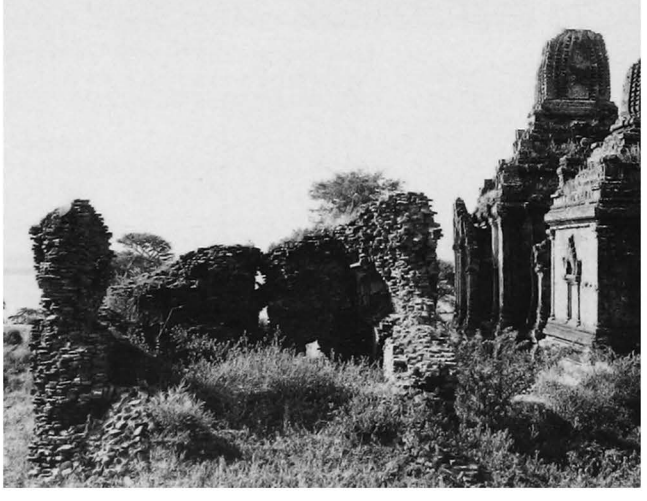
2077 c - From south, together with 2080 and 2079

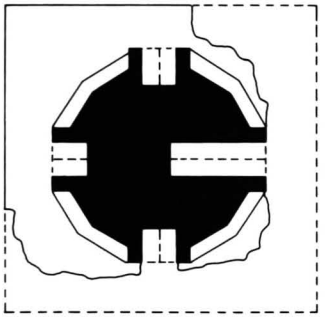
2078 a - Plan

5 present condition
- no maintenance.
- upper parts badly damaged.

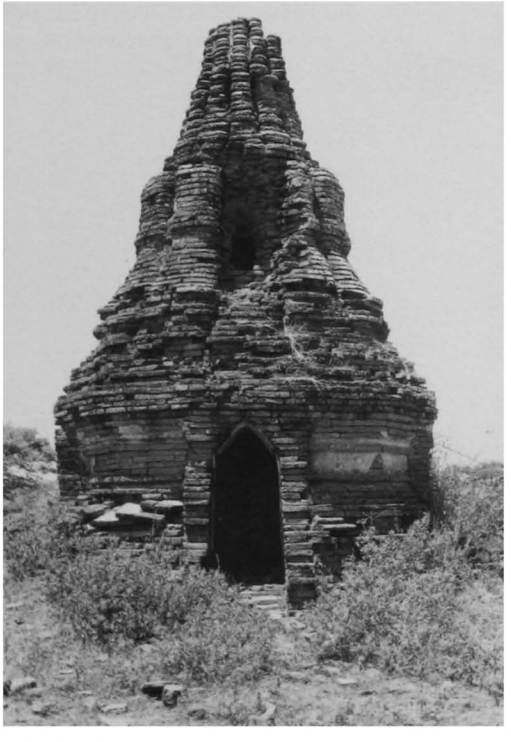
2078 b - East face

2078 c - West face, from north-west

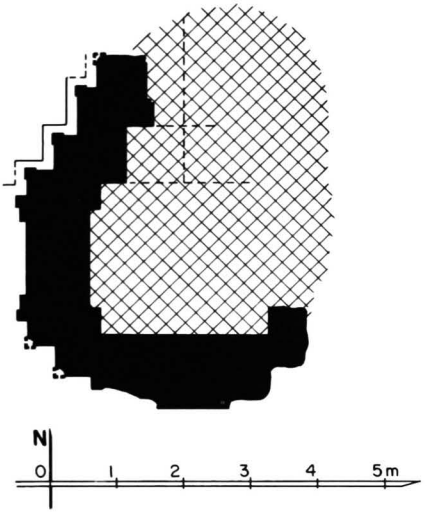
2081 a - Plan

5 present condition
- ruined.
- north-east part destroyed.
- vaults and upper parts collapsed.
- ground floor buried under debris.

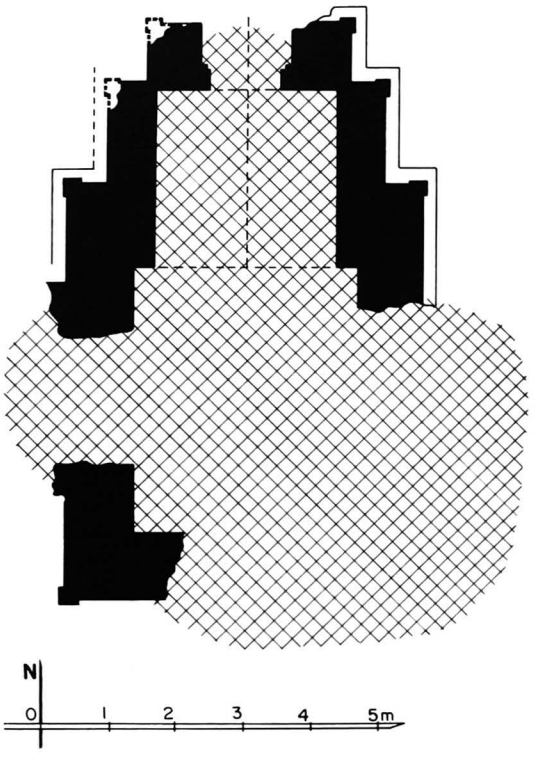
2082 a - Plan

5 present condition
- ruined.
- south-east part destroyed.
- vaults and upper parts collapsed.
- ground floor buried under debris.

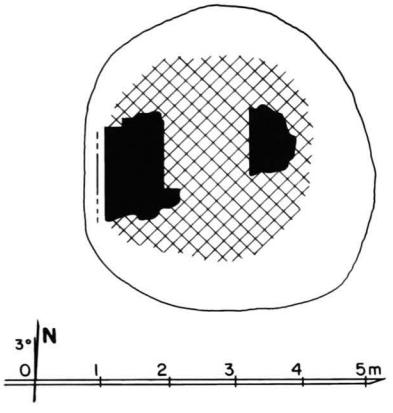
2083 a - Plan

5 present condition
- ruined.
- only base of west and east walls remains.
- ground floor buried under debris.
- present height 1.90 m.

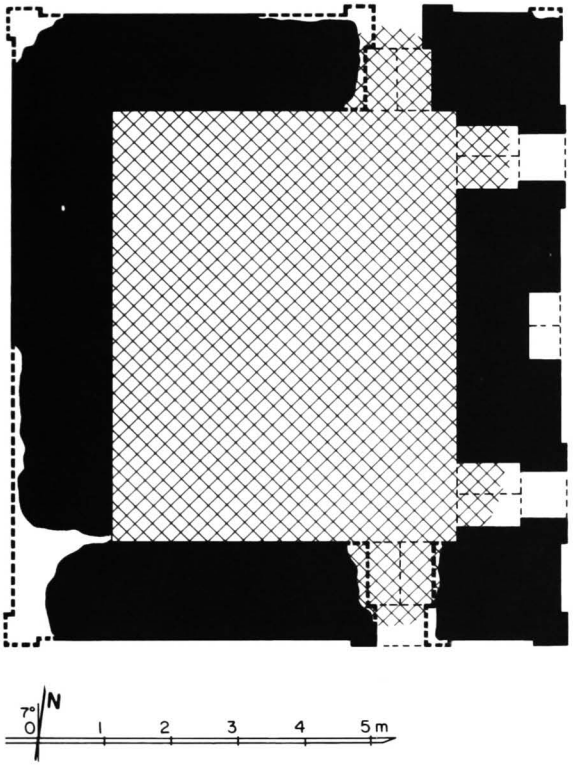
2086 a - Plan

5 present condition
- ruined.
- vault and roof collapsed.
- ground floor buried under debris.

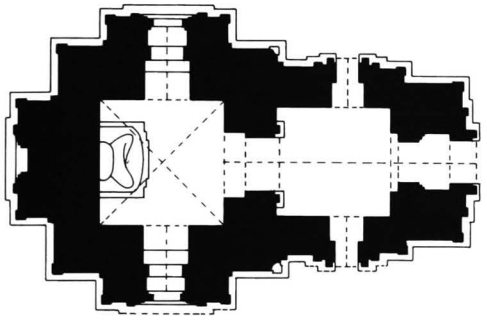
2088 a - Plan

5 present condition
- no maintenance.
- base disintegrated.
- upper parts badly damaged.
- structure cracked.

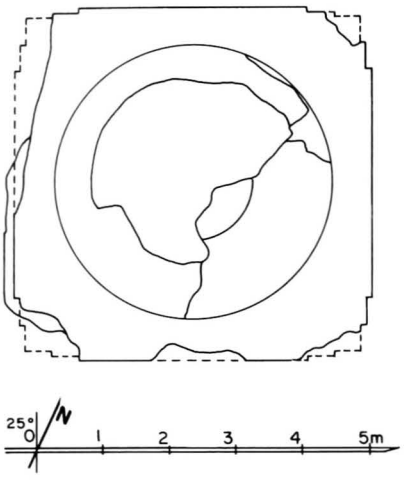
2090 a - Plan

5 present condition
- half-ruined.
- base and terraces disintegrated.
- upper parts badly damaged.

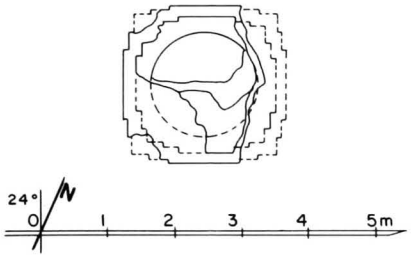
2091 a - Plan

5 present condition
- half-ruined.
- terraces partly destroyed.
- upper parts nearly destroyed.

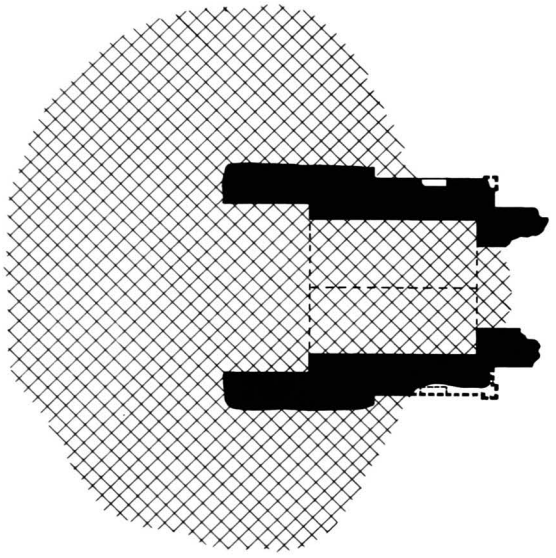
2092 a - Plan

5 present condition
- ruined.
- only vestibule remains.
- ground floor buried under debris.

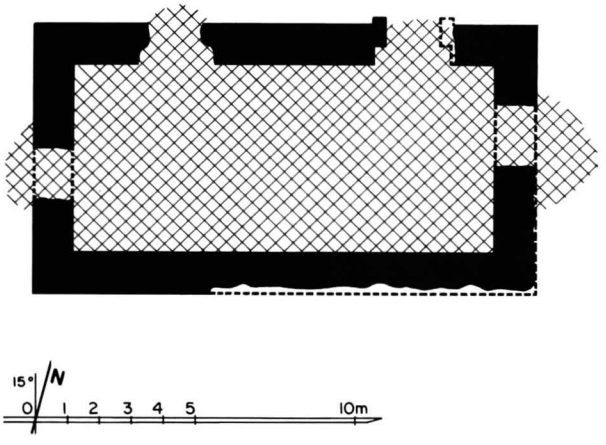
2093 a - Plan

5 present condition
- ruined.
- vault and roof collapsed.
- ground floor buried under debris.

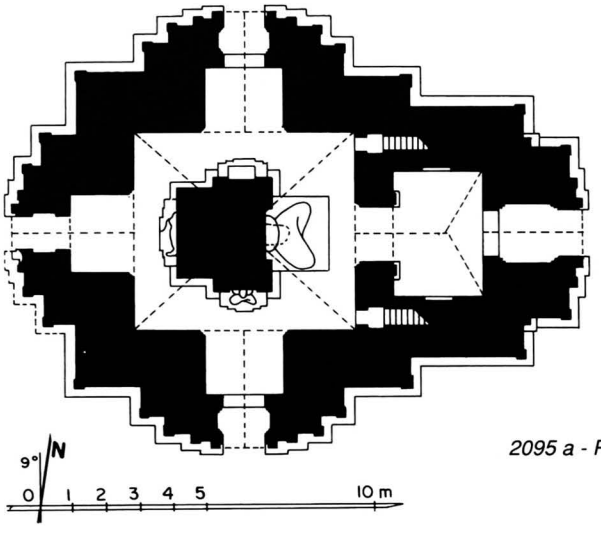
2095 a - Plan

5 present condition
- upper parts damaged.
- structure badly cracked.
- repaired (Arch. Dept.) 1993.

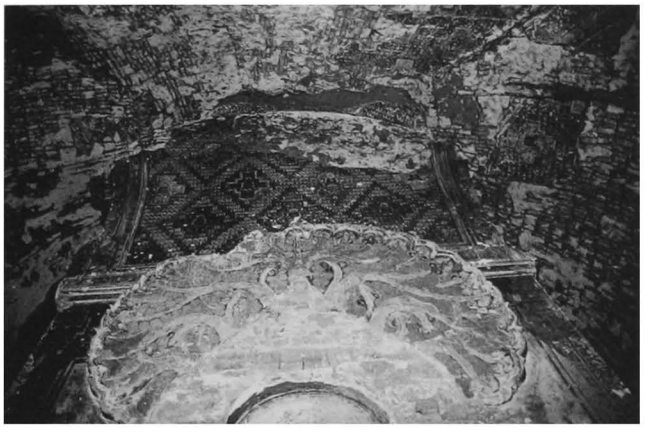
2095 e - Shrine vault and core east face with Bodhi tree, from east

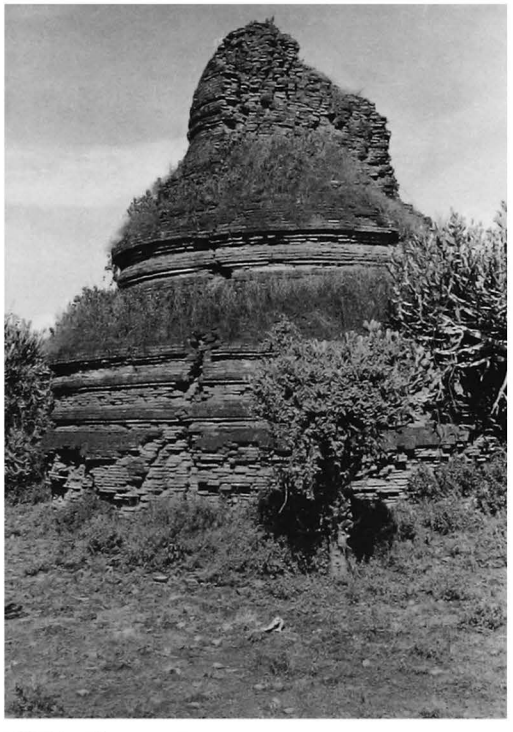
5 present condition
- no maintenance.
- terraces damaged and cracked.
- upper parts badly damaged.

2096 b - From east

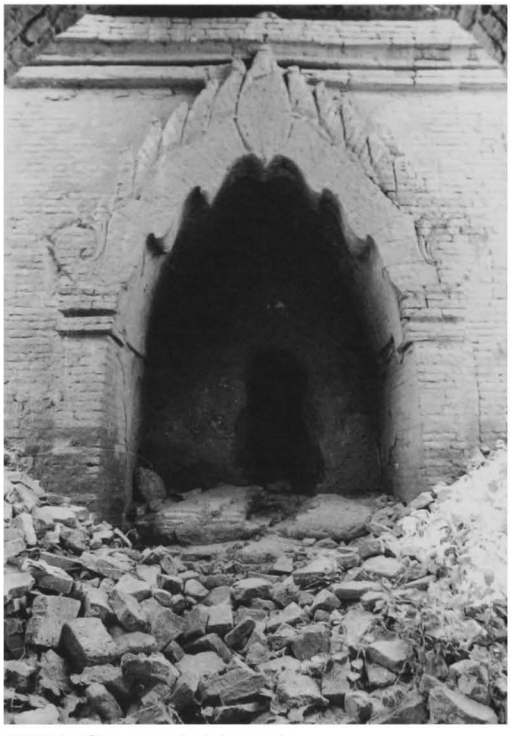
5 present condition
- half-ruined.
- east wall collapsed.
- vaults over corridor collapsed.
- ground floor partly buried under debris.

2097 i - Core, west niche and remains of image, from west

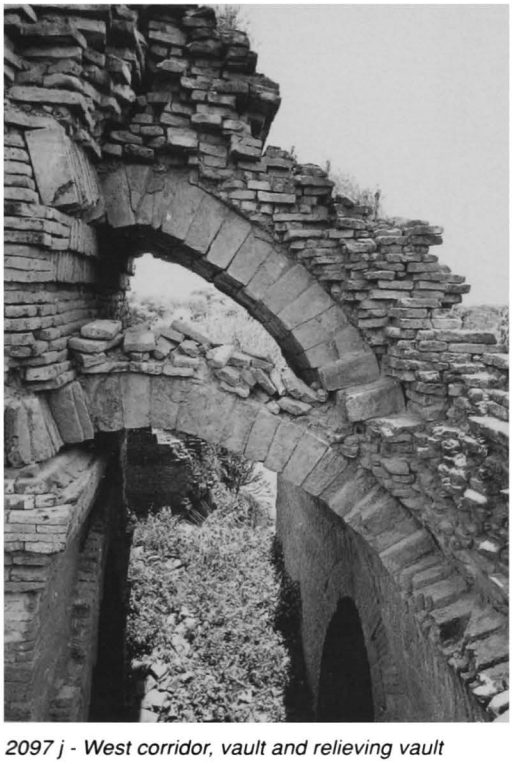
2097 j - West corridor, vault and relieving vault

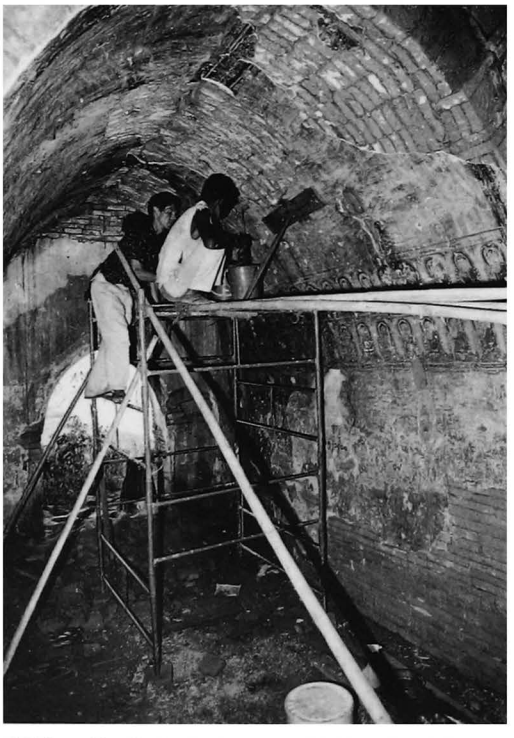
5 present condition
- no maintenance.
- base disintegrated.
- east porch destroyed.
- upper parts damaged.
- emergency consolidation of mural paintings, 1988.

2105 g - Vestibule during consolidation of paintings

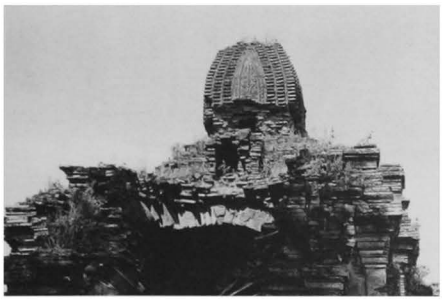
2113 d - Upper parts, east face (1988)

5 present condition
- repaired (Arch. Dept.), 1993.

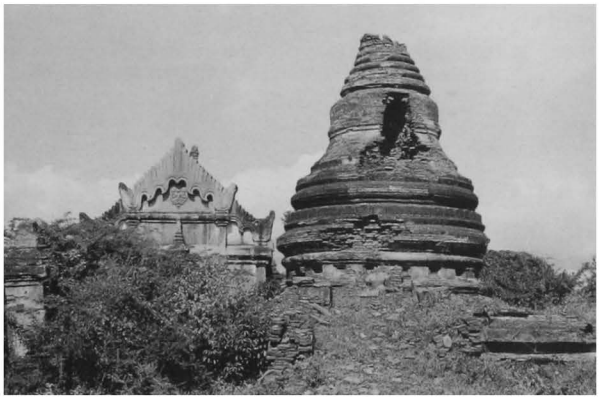
5 present condition
- platform and base damaged.
- upper parts badly damaged.
- repaired (Arch. Dept. 1995-96)

2120 b - From east (1988), together with 2120

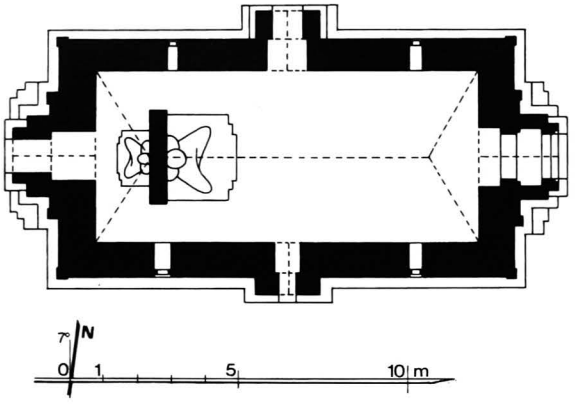
2121 a - Plan

5 present condition
- strengthened 1965 (reinforced concrete ring-beam inserted).
- vault bent and badly cracked by the 1975 earthquake, with loss of mural paintings.
- temporarily strengthened by internal steel frame (Const. Corp) 1975-81.

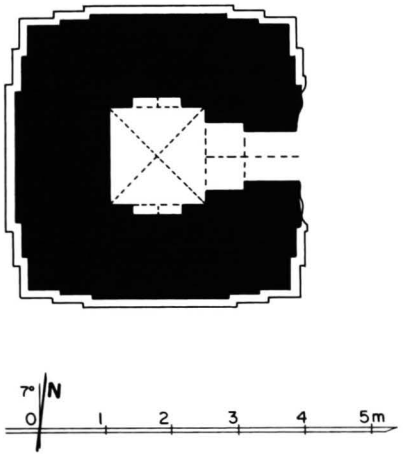
2123 a - Plan

5 present condition
- no maintenance.
- base disintegrated.
- east porch collapsed.
- upper parts badly damaged.

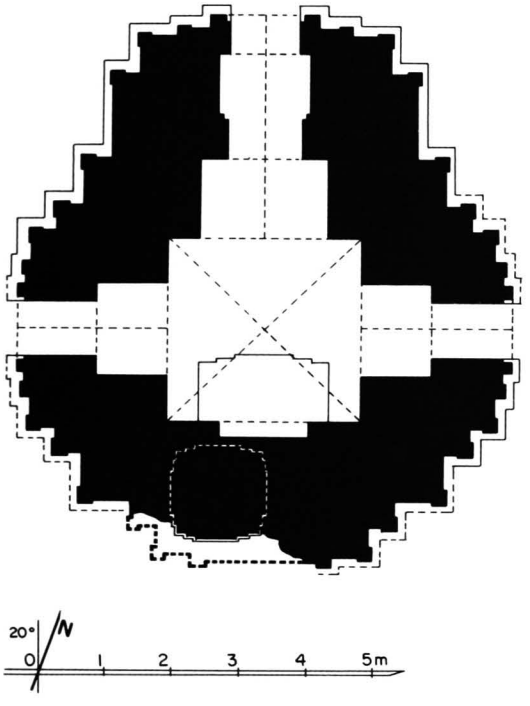
2129 a - Plan

5 present condition
- no maintenance.
- pediments destroyed.
- upper parts badly damaged.

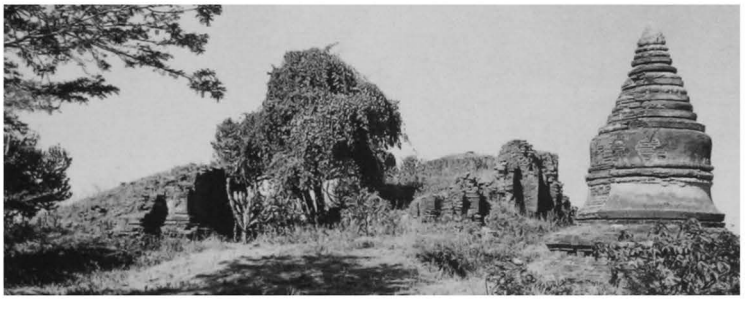
5 present condition
- ruined.
- only base of walls remains.
- ground floor buried under debris.

2130 b - From north-east, together with 2131 and 2133

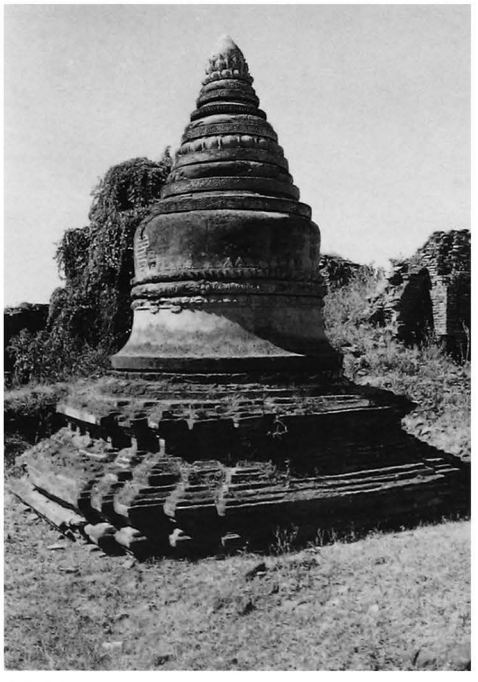
2133 b - From north-east

5 present condition
- maintained.
- a rare instance of intact spire.

remark
- both stupas **2132** and **2133** were formerly encased in a single, large stupa of which the debris were removed in 1968.

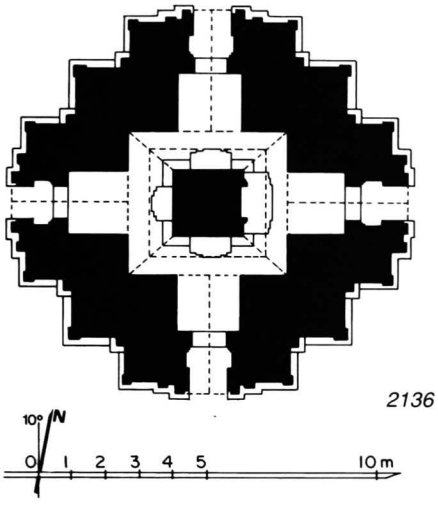
5 present condition
- no maintenance.
- upper parts badly damaged.

2136 b - East face, from north-east

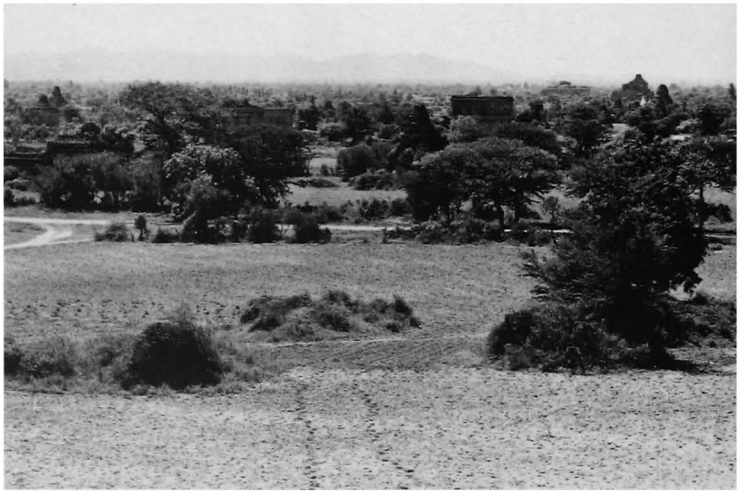
5 present condition
- ruined.
- present height: 1.70 m.
- only base of walls remains.
- excavated (Arch. Dept.) 1995-96.

2139 b - From north, before excavation

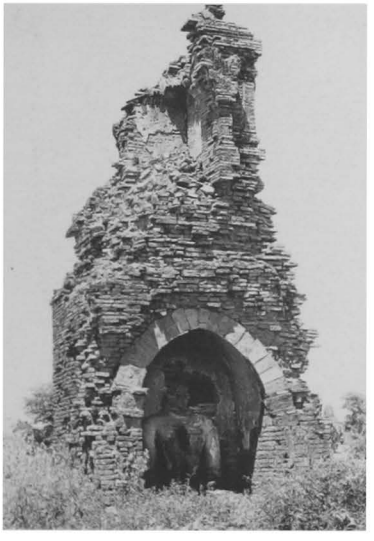
5 present condition
- half-ruined.
- base disintegrated.
- upper storey half destroyed.
- upper parts collapsed.
- ground floor buried under debris.

2142 c - Upper storey, east face

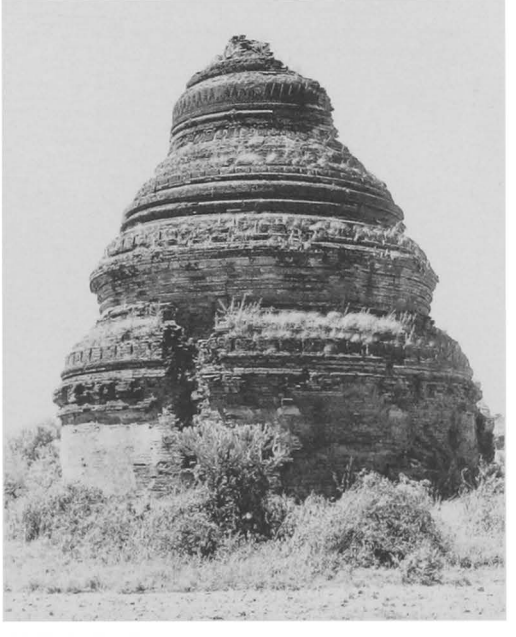
5 present condition
- no maintenance.
- base and terraces damaged.
- upper parts badly damaged.

2146 d - South face

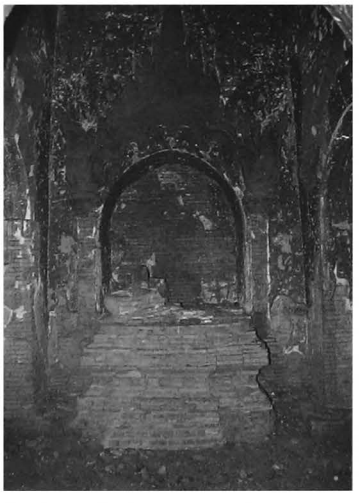
2149 e - Shrine from east

5 present condition
- maintained.
- tower damaged by the 1975 earthquake.
- base repaired (Arch. Dept.).
- tower repaired (Arch. Dept.).

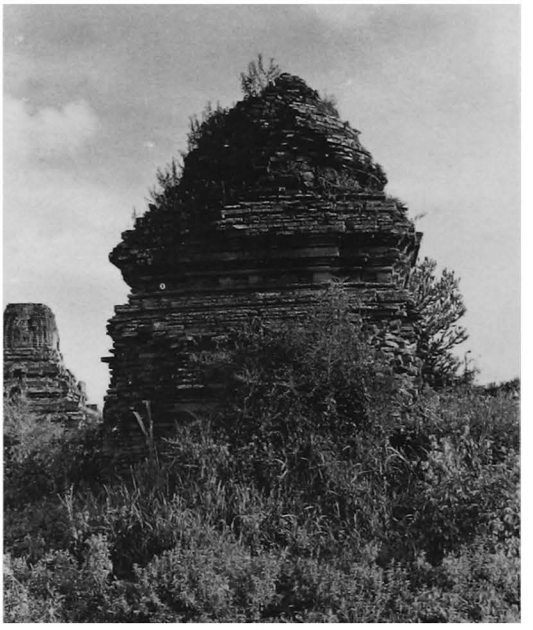
5 present condition
- half-ruined.
- base and terraces disintegrated.
- upper parts nearly destroyed.

2152 d - North face

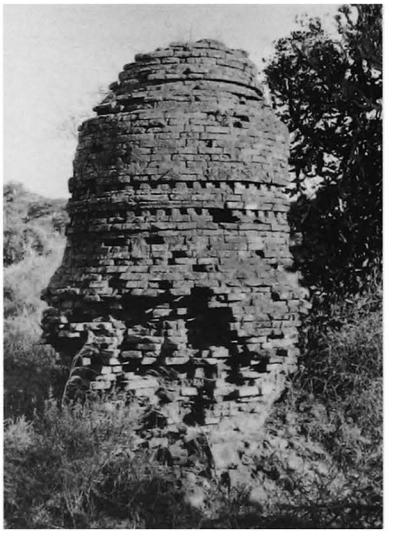
5 present condition
- half-ruined.
- terraces disintegrated.
- upper parts badly damaged.

2154 d - From north-east

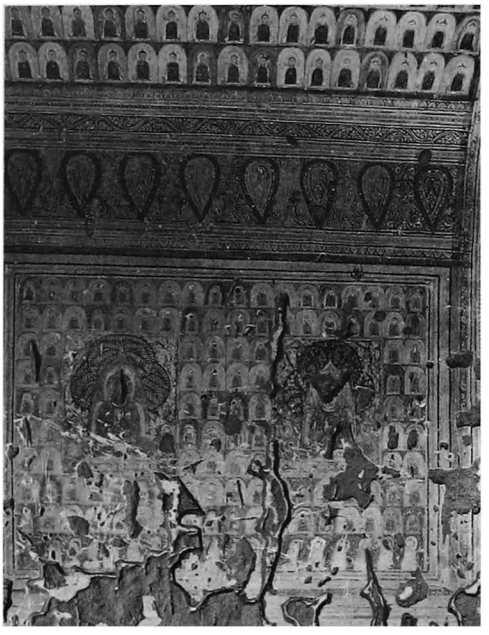
2155 e - Vestibule, north wall

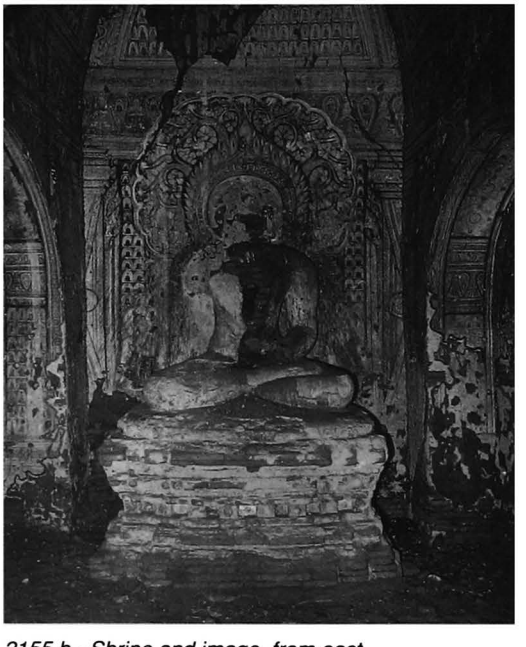
6 image
- 1 seated Buddha, facing east (damaged and headless).

2155 h - Shrine and image, from east

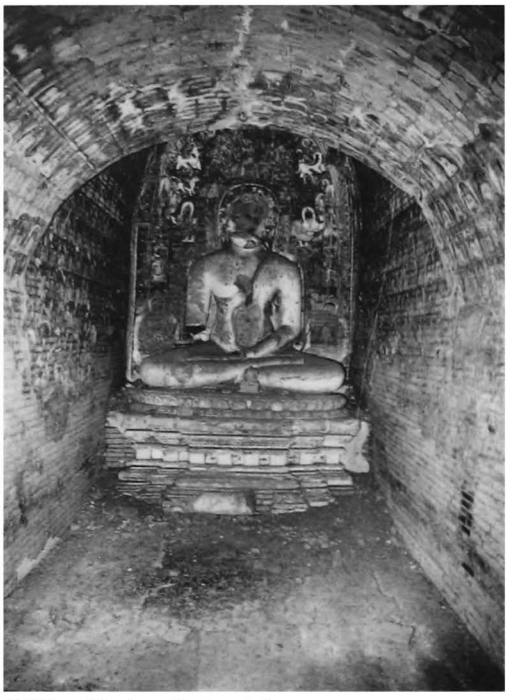
2157 e - East vestibule, shrine and image, from east

6 image
- 1 seated Buddha, facing east (damaged and headless).

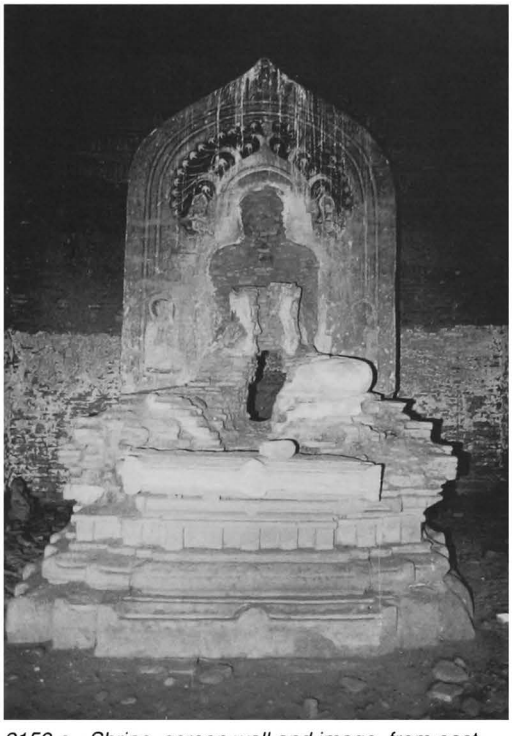
6 image
- 1 seated Buddha, facing east (damaged and headless), on a stone pedestal against a screen wall.

2159 e - Shrine, screen wall and image, from east

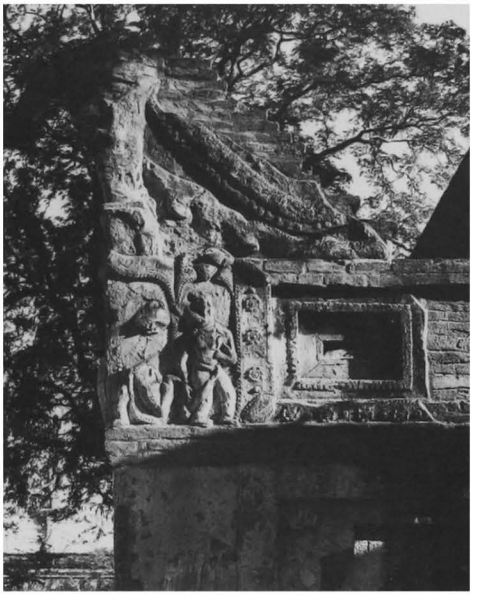
2162 e - Platform, north face, north-east corner, detail from north

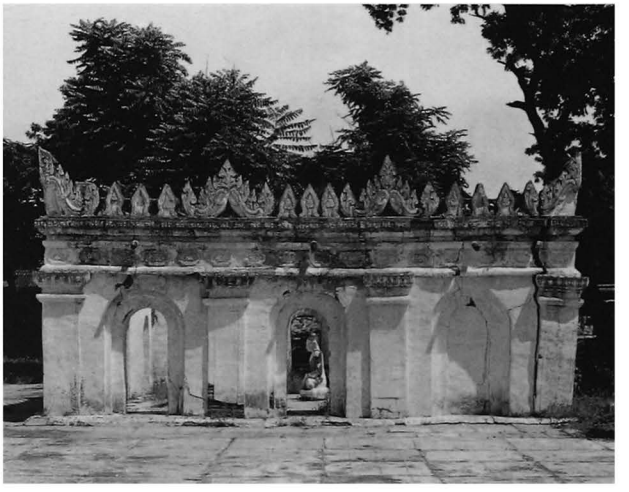
2169 b - From east

5 present condition
recently demolished by Ananda Trustees.

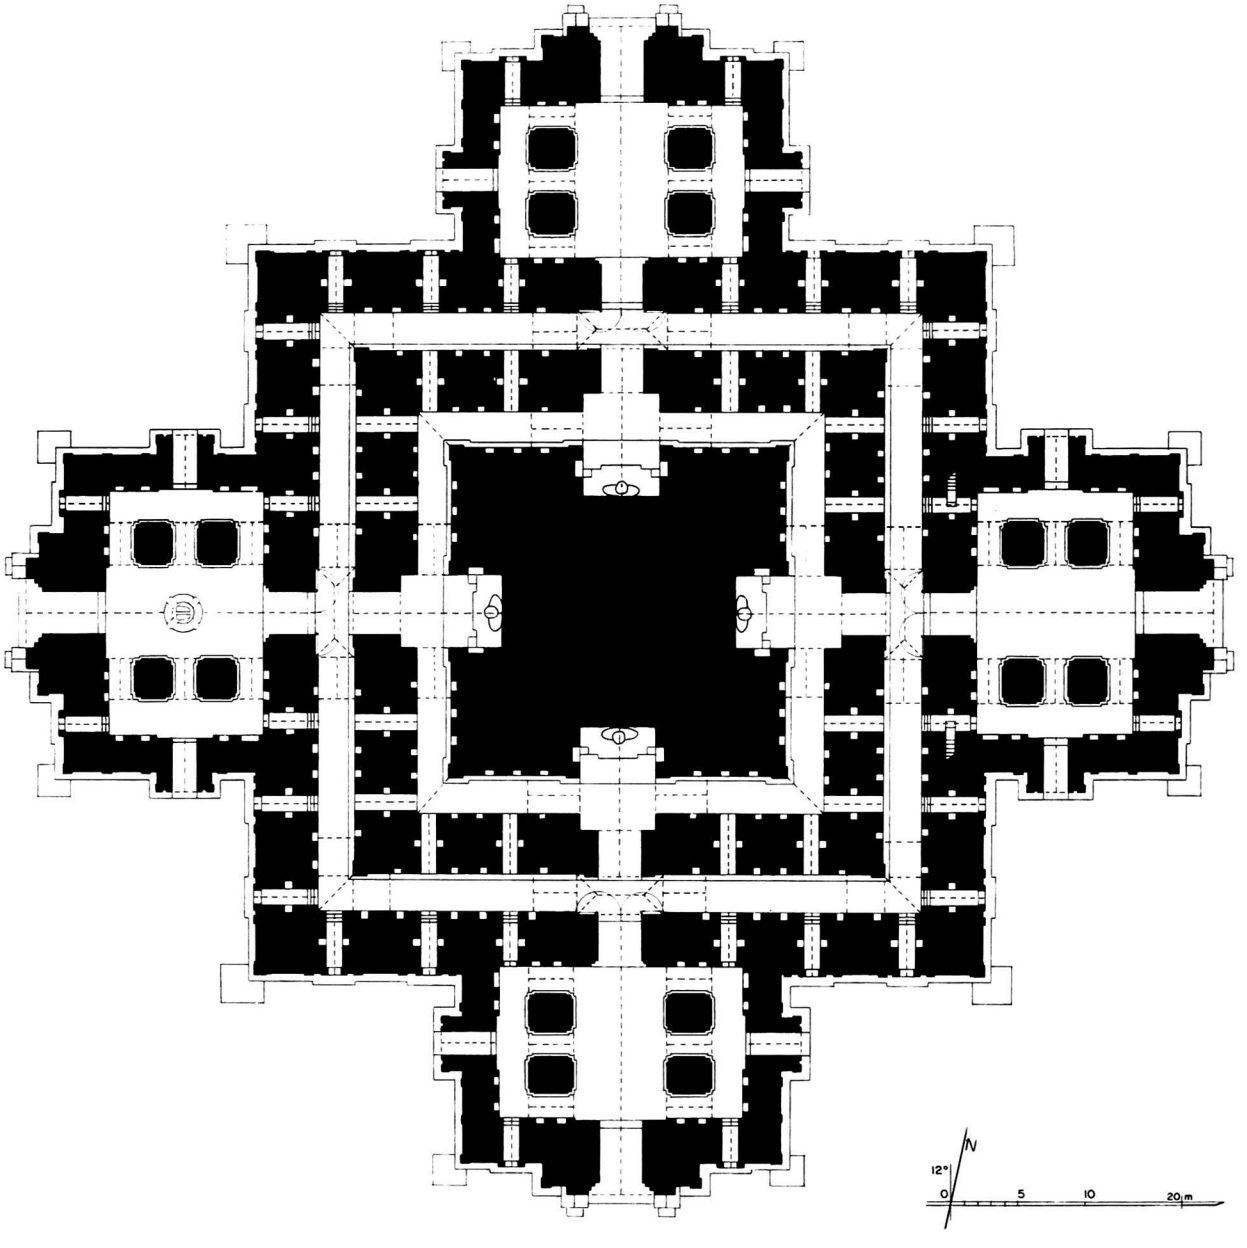
2171 a1 - Plan

5 present condition
- maintained by Trustees.
- whitewashed.
- upper parts badly damaged by the 1975 earthquake, tower repaired and strengthened with an inner reinforced concrete shell (Const. Corp.) 1976-80.

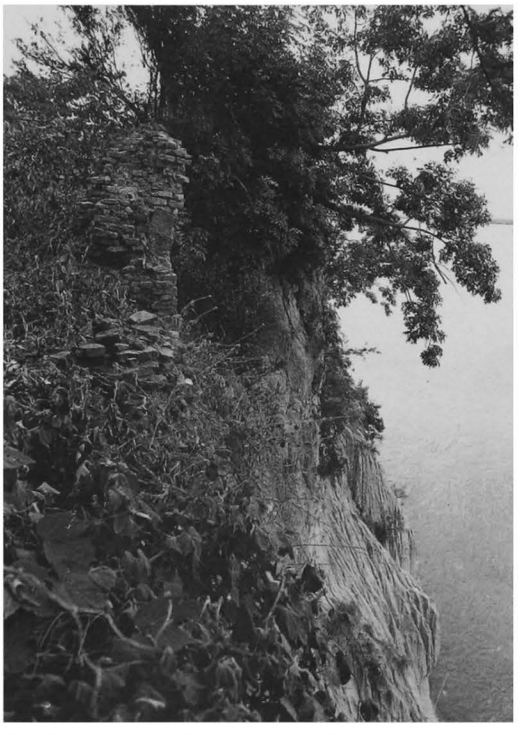
2177 c - Detail of wall, from east

5 present condition
- ruined.
- destroyed by river erosion.
- only part of south wall remains.

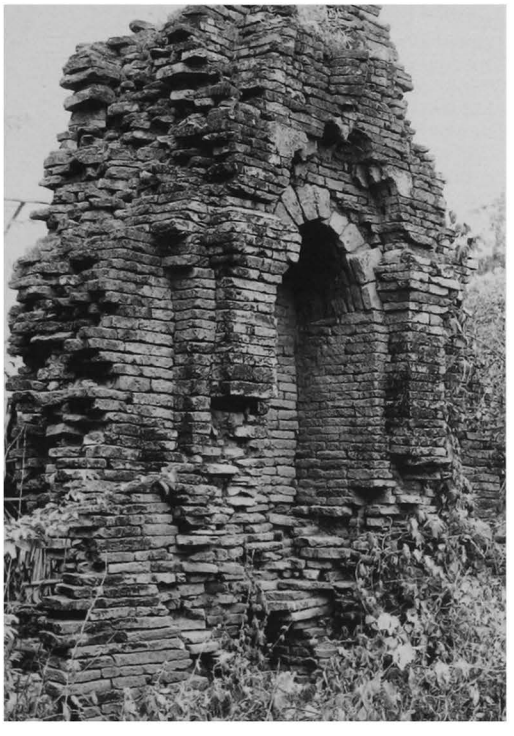
2179 b - East face, from south-east

5 present condition
- ruined.
- only central part of east wall remains.

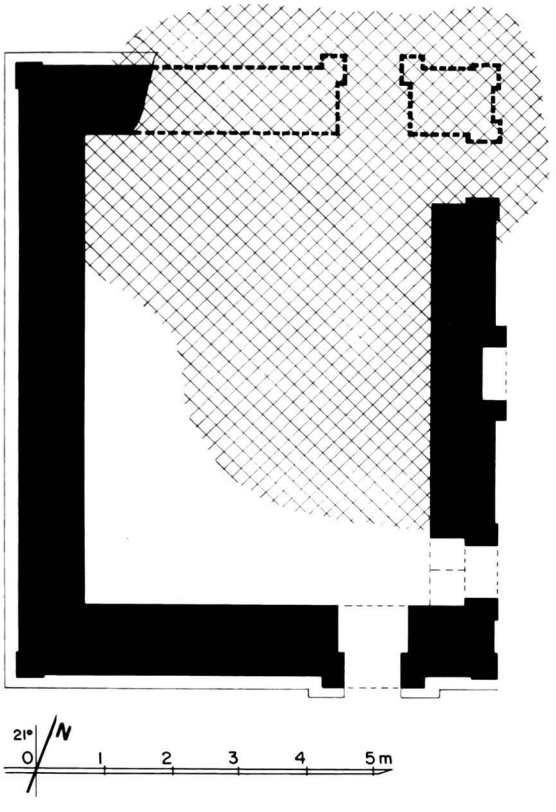
2181 a - Plan

5 present condition
- ruined.
- north-east corner collapsed.
- vault and roof collapsed.
- ground floor buried under debris.

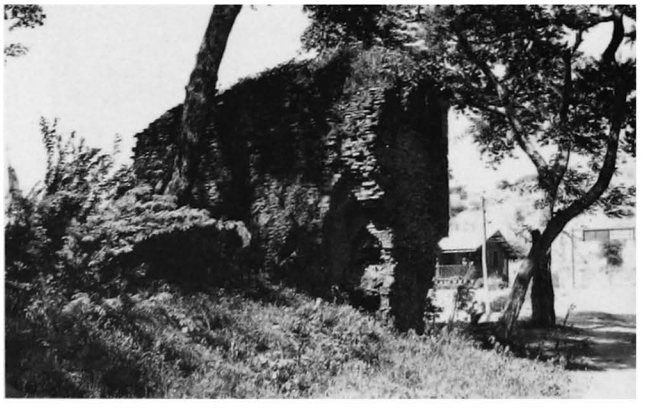
2182 b - From north-west

5 present condition
- ruined.
- only north-west corner remains.
- ground floor buried under debris.

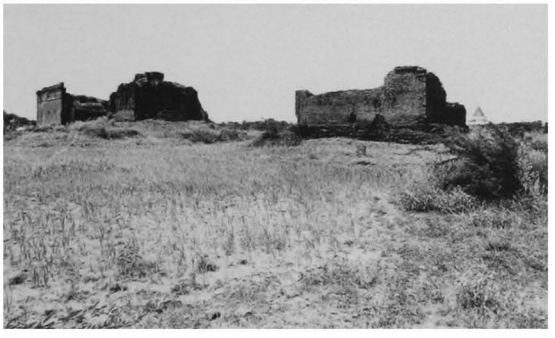
2183 b - From south-west, together with 223 and 2180

5 present condition
- ruined.
- east part destroyed.
- vault and roof collapsed.
- ground floor buried under debris.

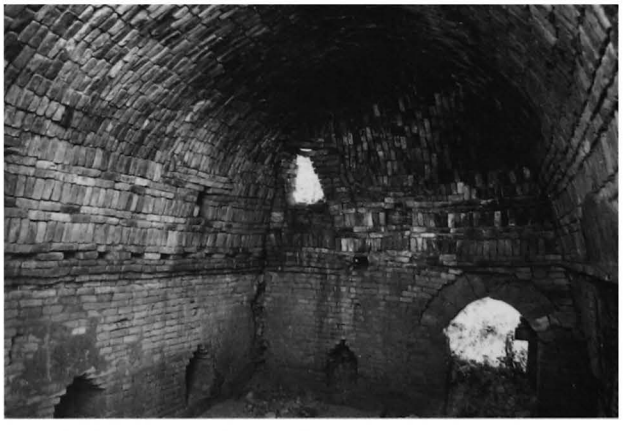
2186 d - Central room, from south east

5 present condition
- half-ruined.
- vault partly collapsed.

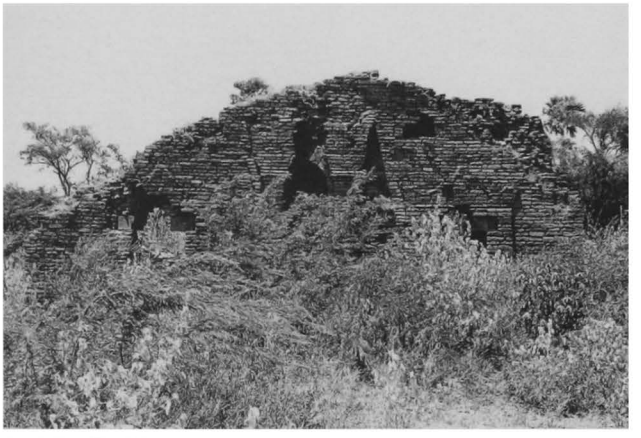
2187 b - East face

5 present condition
- ruined.
- vault and roof collapsed.
- ground floor buried under debris.

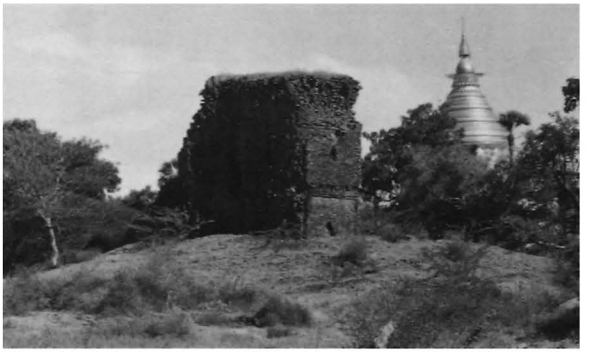
2192 b - From south-west, together with 1 Shwe-zigon

5 present condition
- ruined.
- walls and vault of corridor collapsed.
- ground floor buried under debris.

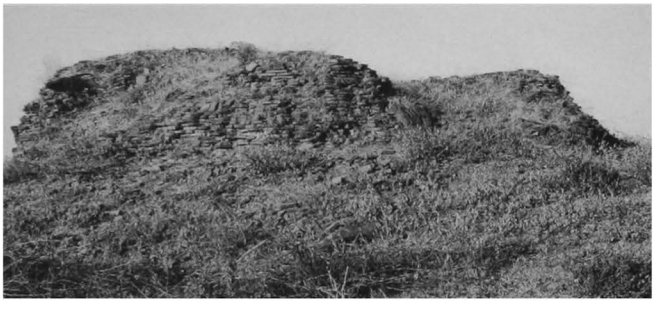
2204 b - From south-west

5 present condition
- ruined.
- vaults and upper parts collapsed.
- ground floor buried under debris.

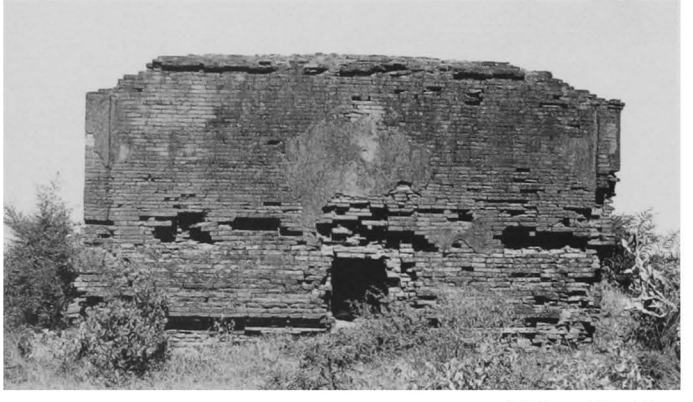
2209 c - West face

5 present condition
- ruined.
- vaults and upper parts collapsed.
- ground floor buried under debris.

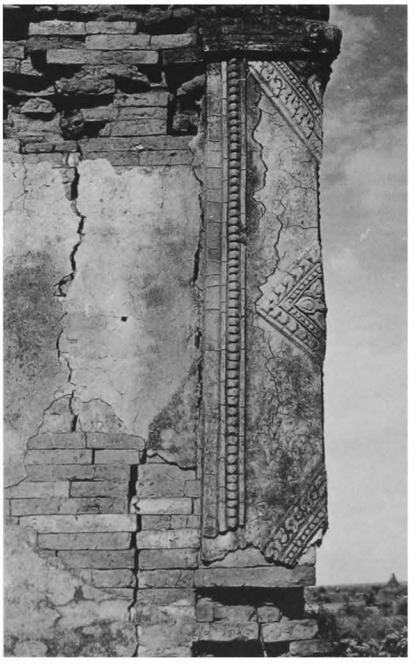
2211 c - West face, south-west corner, detail of pilaster

5 present condition
- half-ruined.
- vaults and upper parts collapsed.
- ground floor buried under debris.

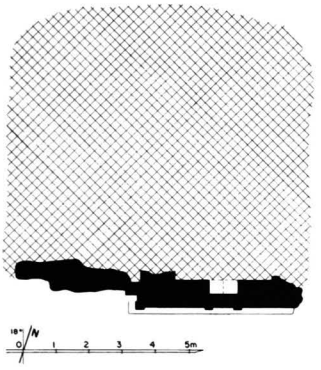
2213 a - Plan

5 present condition
- ruined.
- only south wall remains.
- vaults and upper parts collapsed.
- ground floor buried under debris.

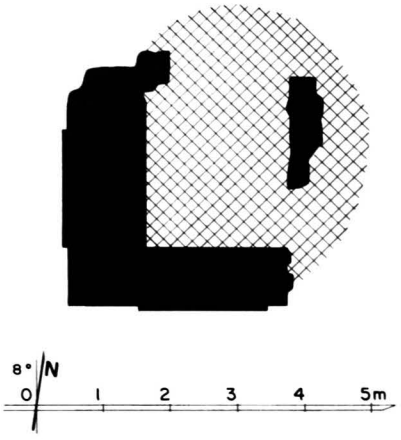
2214 a - Plan

5 present condition
- ruined.
- vaults and upper parts collapsed.
- ground floor buried under debris.

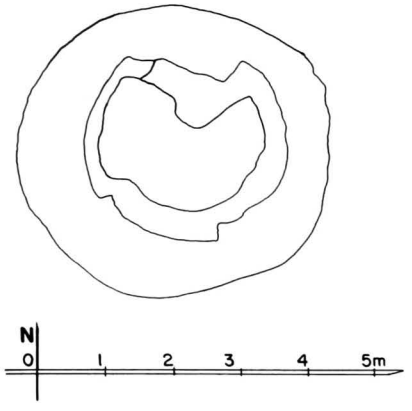
2215 a - Plan

5 present condition
- ruined.
- base and terraces disintegrated.
- upper parts destroyed.

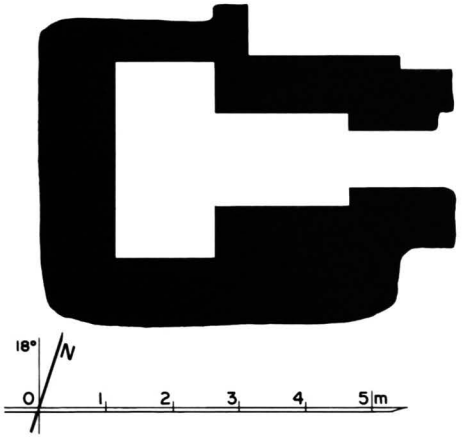
2226 a - Plan

5 present condition
- ruined.
- only base of walls remains.

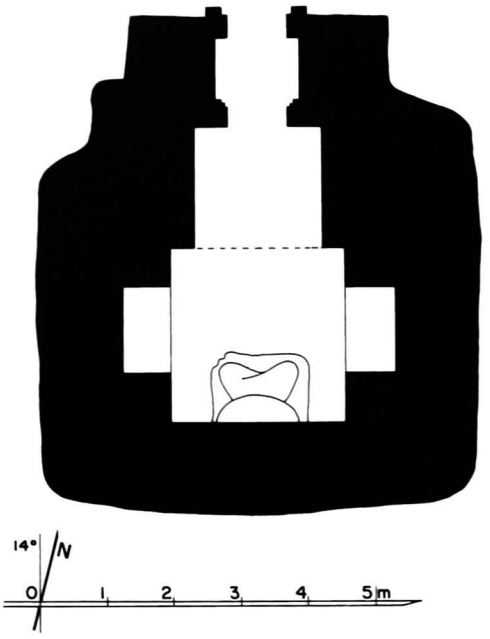
2227 a - Plan

5 present condition
- ruined.
- only base of walls remains.

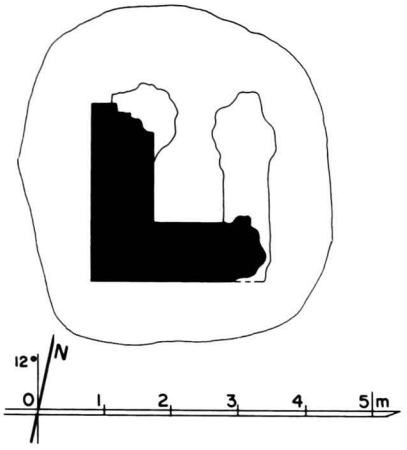
2228 a - Plan

5 present condition
- ruined.
- only base of walls remains.
- present height: approx. 1.30 m.

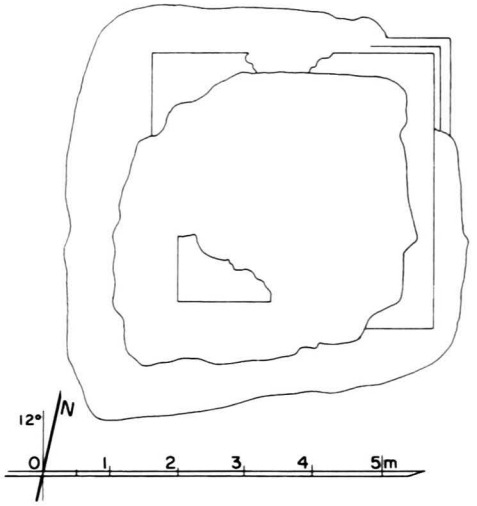
2229 a - Plan

5 present condition
- ruined.
- base only remains.
- present height: approx. 1.60 m.

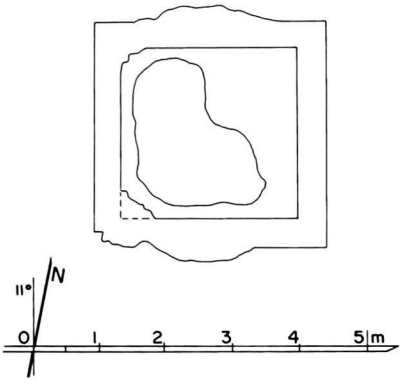
2230 a - Plan

5 present condition
- ruined.
- base only remains.
- present height: approx. 1.80 m.

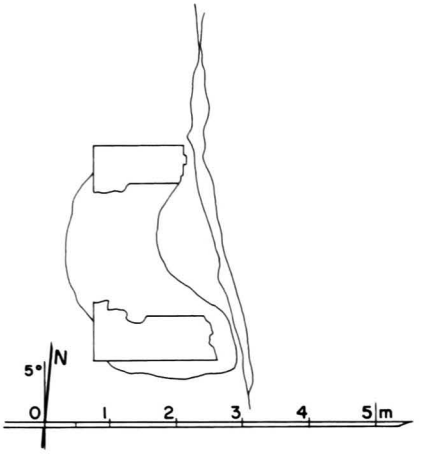
2231 a - Plan

5 present condition
- ruined.
- east part destroyed by cliff erosion.

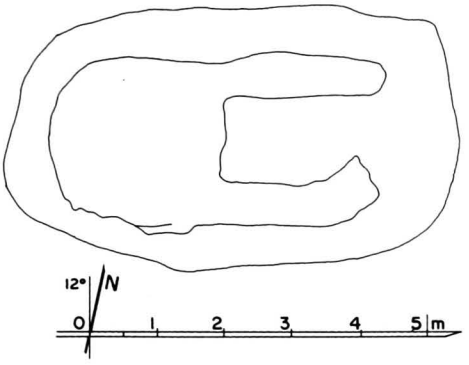
2232 a - Plan

5 present condition
- ruined and buried under debris.
- present height: approx. 1.20 m.

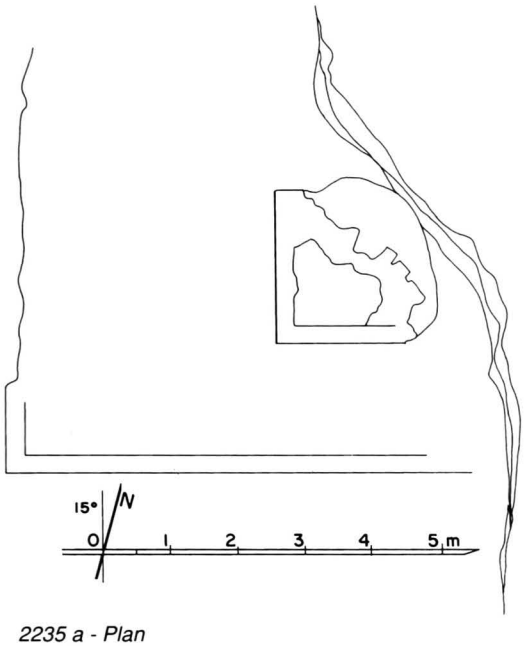
2235 a - Plan

5 present condition
- ruined.
- base only remains.
- present height: approx. 1.40 m.

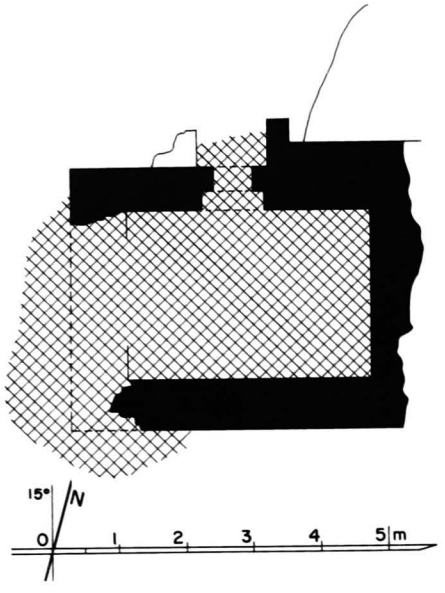
2236 a - Plan

5 present condition
- ruined.
- only base of walls remains.

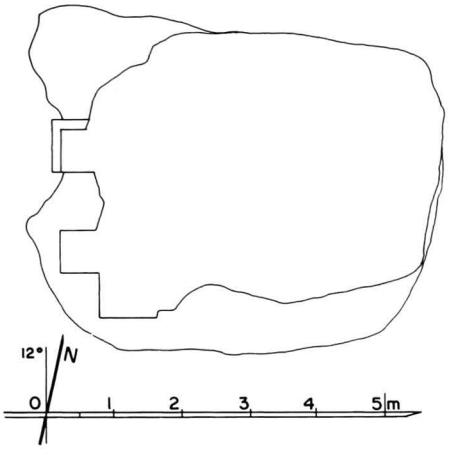
2237 a - Plan

5 present condition
- ruined and buried under debris.

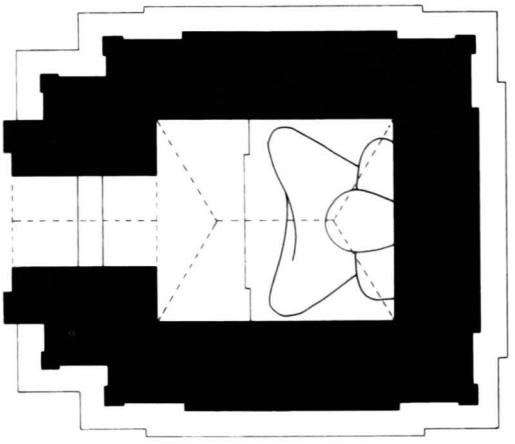
2238 a - Plan

5 present condition
- maintained and whitewashed.
- vaults rebuilt in 1926.
- damaged by the 1975 earthquake, repaired 1976.

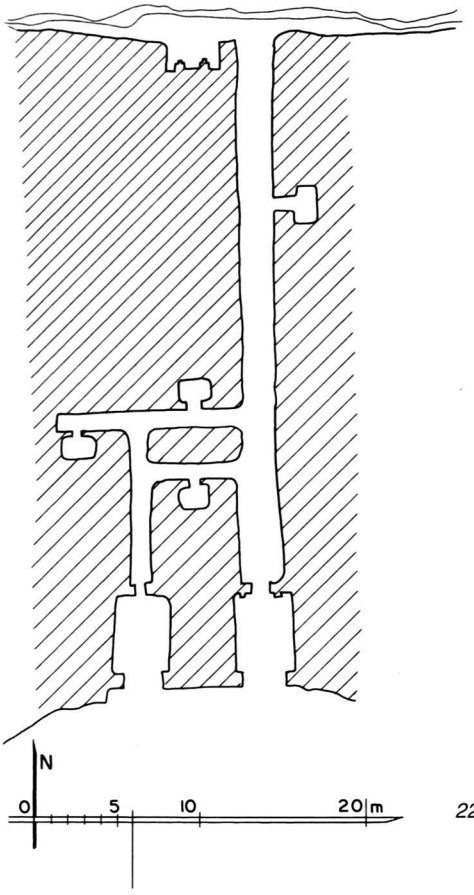
2244 a - Plan

5 present condition
- no maintenance.
- north side endangered by erosion of river cliff.

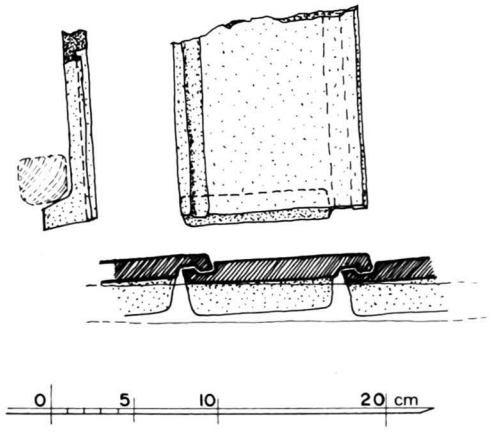
2303 a2 - Details of roof-tiles with hooks and grooves

remark
- fragments of roof-tiles give evidence of a flat, rectangular model, 8 to 11 cm wide, length unknown, with hook and lateral alternate grooves for interlocking.
